Manhole Inspection Summary

Manhole # S05II2023MH

Location Address: **6306 SHELICK DR**

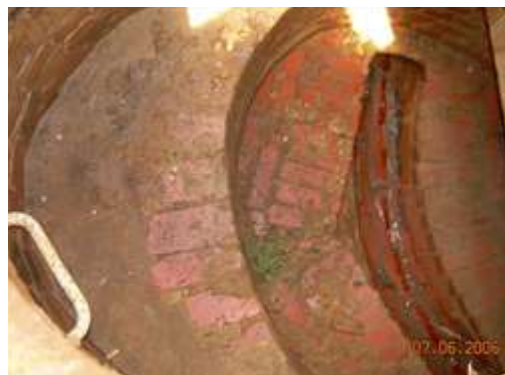
Top View

Adjustment, Corbel, and Barrel infiltration.
Evidence of surcharge - Bench debris.

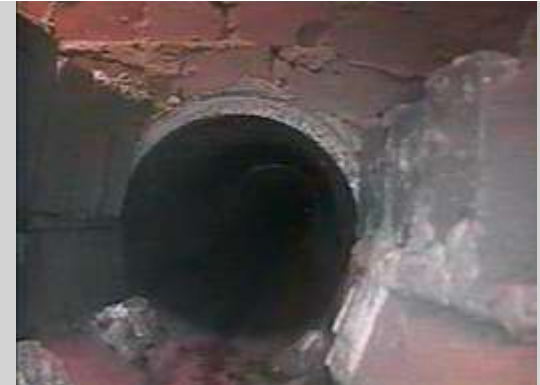
8 in. Circular Gravity Sewer Pipe Out @ 12 O'Clock

Comments **The O12 pipe picture shows grease deposits in the Channel. The I4 pipe seal is not flush to the pipe.**

Infiltration: **Evidence** Pipe Seal Cond: **Unknown**

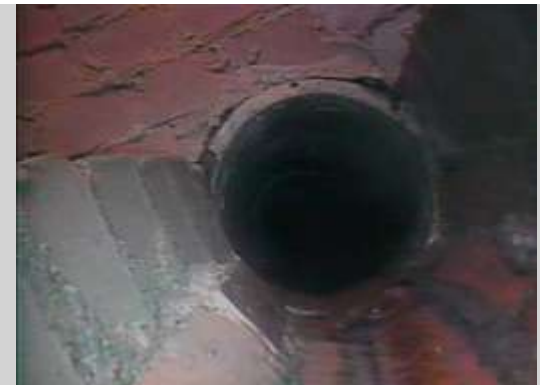
8 in. Circular Gravity Sewer Pipe In @ 4 O'Clock

Infiltration: **Evidence** Pipe Seal Cond: **Unknown**
